DEPARTMENT OF TRANSPORTATION

Contract #: 04-0120F4Cty: SF/ALA Rte: 80 PM: 13.2/13.9File #: 1.28**WELDING INSPECTION REPORT****Resident Engineer:** Pursell, Gary**Address:** 333 Burma Road**City:** Oakland, CA 94607**Report No:** WIR-014312**Date Inspected:** 21-May-2010**Project Name:** SAS Superstructure**OSM Arrival Time:** 630**Prime Contractor:** American Bridge/Fluor Enterprises, a JV**OSM Departure Time:** 1500**Contractor:** American Bridge/Fluor Enterprises, a JV**Location:** Job Site

WELDING INSPECTION REPORT

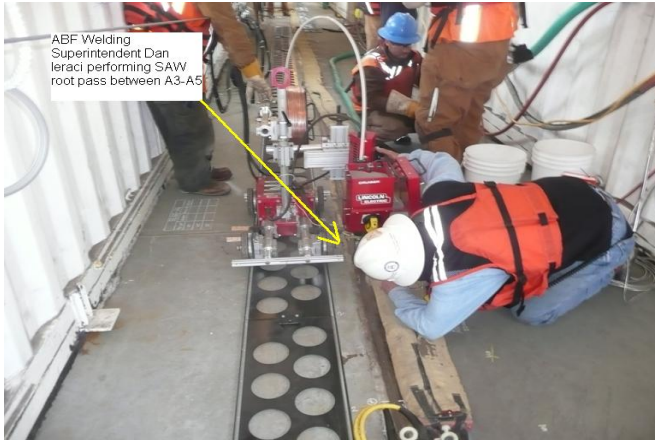
The QA Inspector randomly observed the ABF welding operator/Superintendent Dan Ieraci began welding the SAW root pass in the center of A3 and weld to the end of section A5. The QA Inspector randomly observed the SAW parameters and they were 555 Amps, 32.3 Volts and a travel speed of 368mm/min. The QA Inspector noted the SAW parameters appeared to be in general compliance with ABF-WPS-D1.5-4042B-1. After the root pass was completed between the center of A3-A5, the SE QC Inspectors were setting up to perform the magnetic particle testing (MT) prior to the 1200 lunch break. The QA Inspector noted no additional ABF welding operator began performing the SAW root pass between A3-A1. The QA Inspector randomly observed the ABF welding operator

Jordan Hazelaar attempt to begin the SAW root pass before he was stopped by Dan Ieraci. Mr. Ieraci informed the ABF welder he would perform the root pass him self. The QA Inspector noted the SAW root pass between A1-A3 was not completed on the QA Inspectors shift.
